STUDY DOCUMENT

SCHOOL DISTRICT OF RHINELANDER

Bray Associates Architects, Inc.

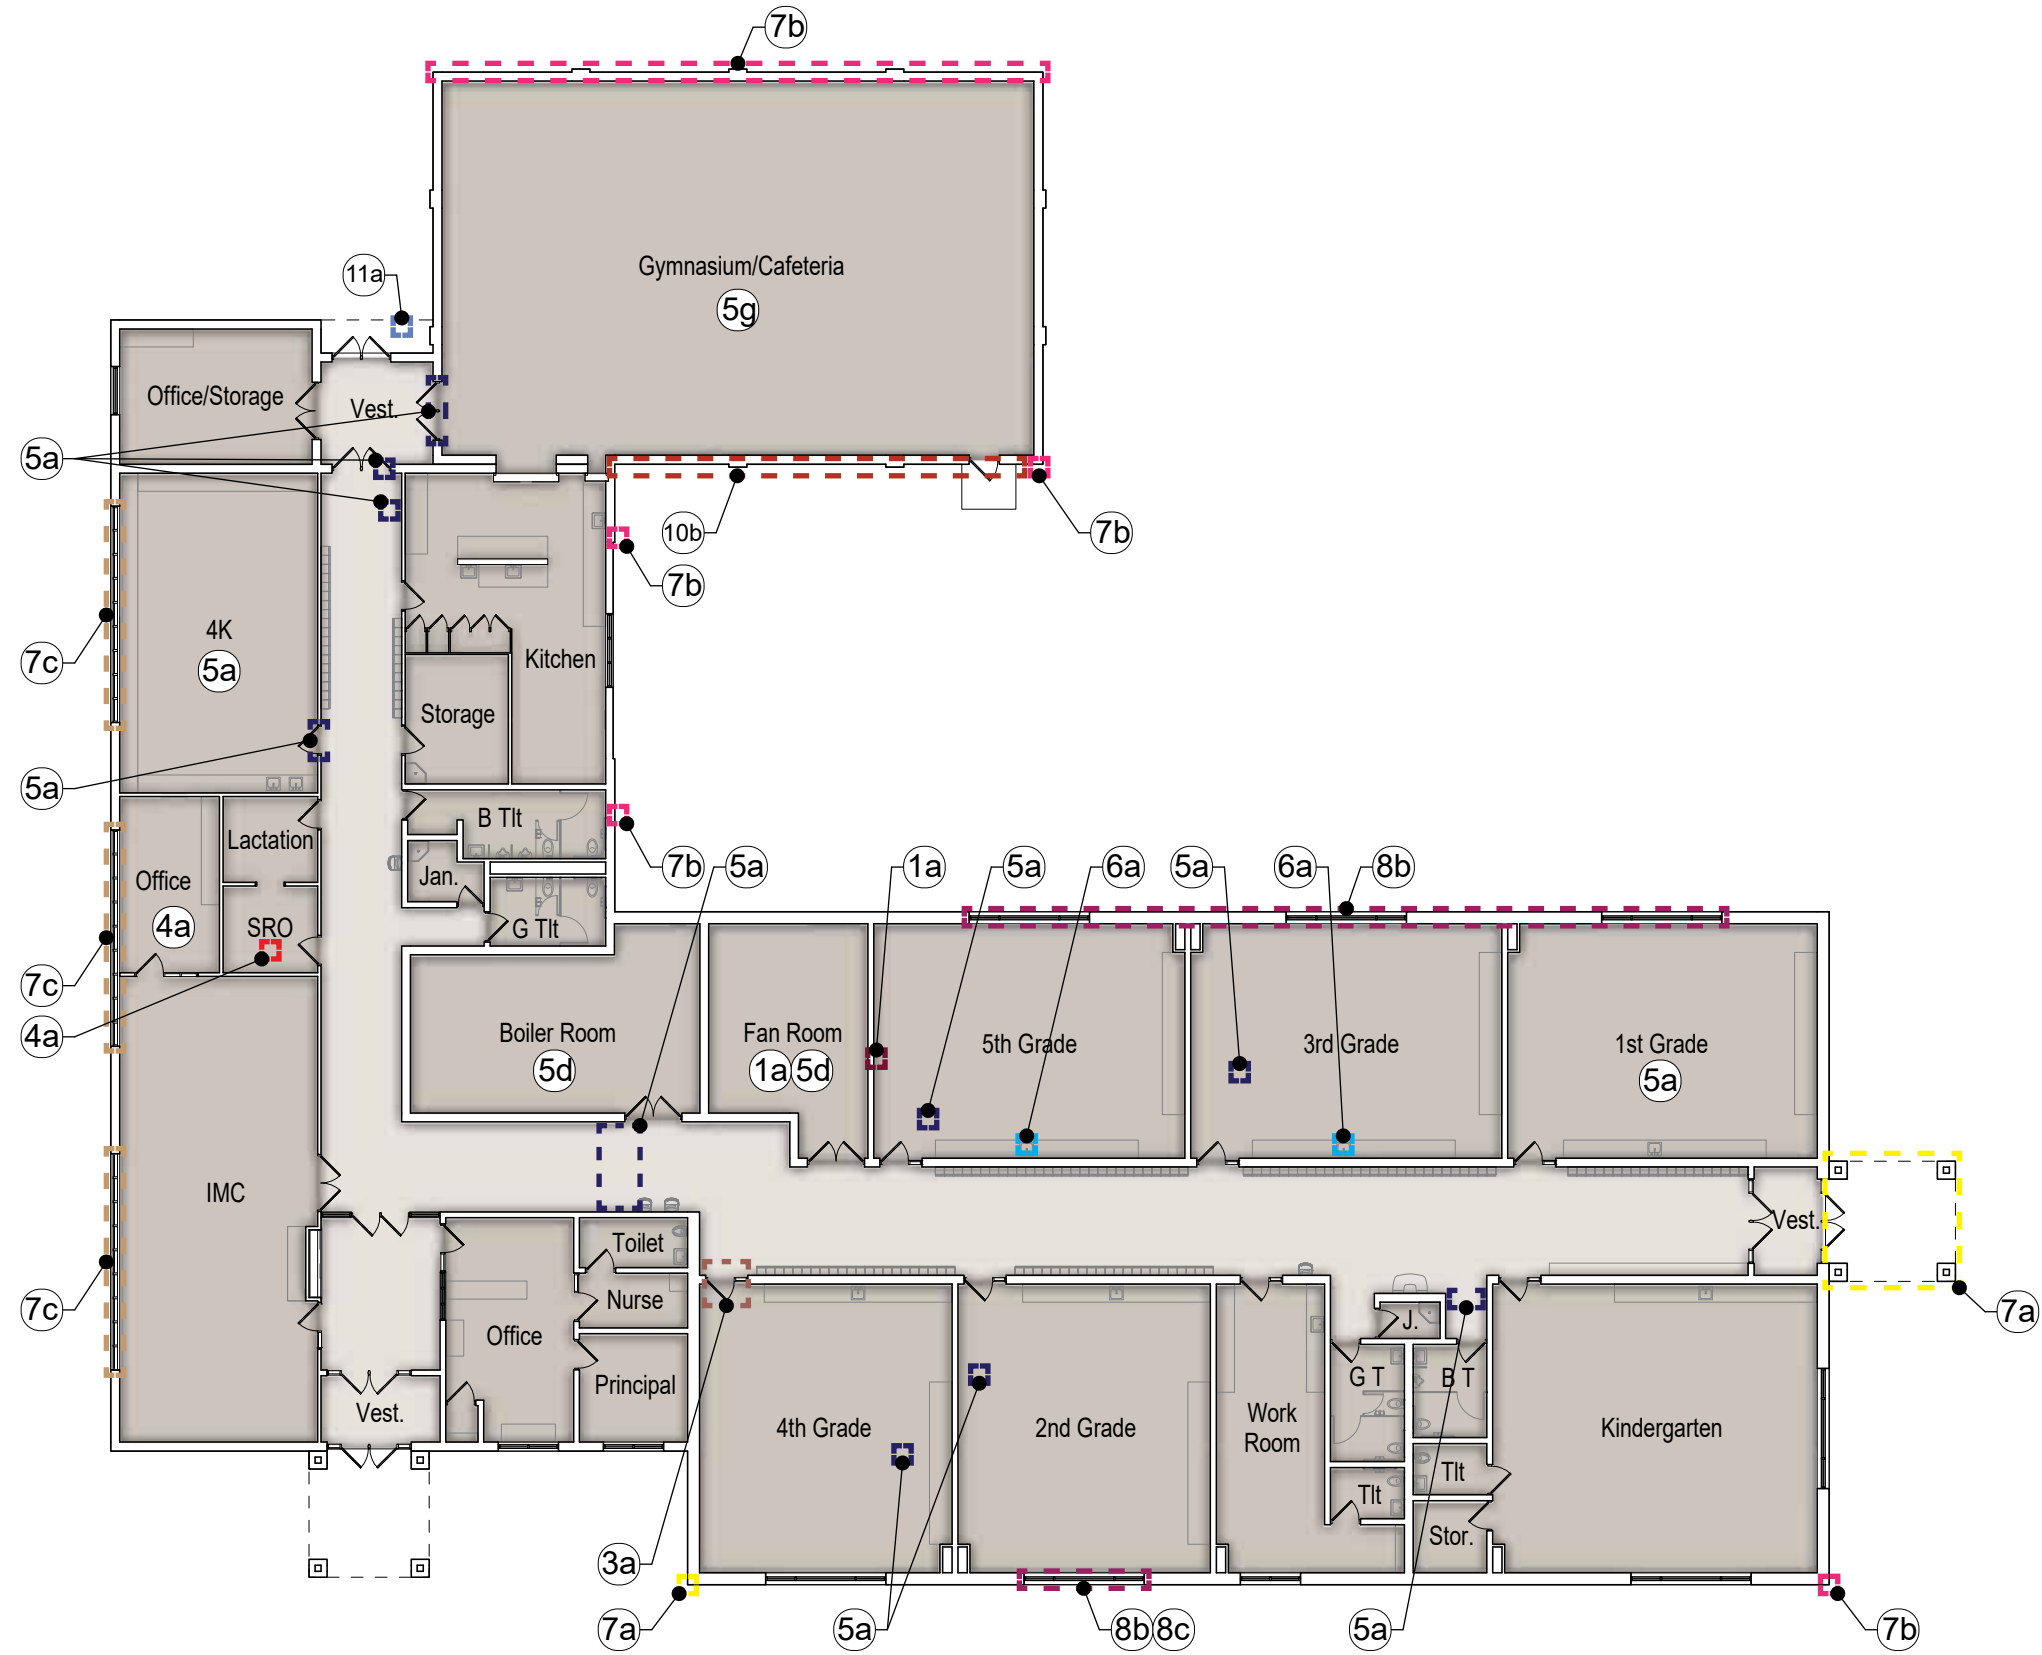
FIRST FLOOR PLAN
not to scale

No.	Northwoods Comm. Elementary	Type / Material	Area / Location	Analysis	Identified in Plans
Infrastructure Improvement					
Building Interior					
1	Walls				
a	Walls	concrete block	building	instances of patched holes	x
b	Walls	gypsum	building	overall in good condition	
c	Walls	tile	toilet rooms	overall in good condition	
2 Window Interior & Openings					
a	Interior Window	hollow metal	building	overall in good condition	
b	Interior Window Sills	laminate	building	overall in good condition; few instances of chipping	
3 Interior Doors					
a	Interior Doors - Door / Frame	wood / hollow metal	building	overall in good condition; few instances of chipping and/ or discoloring, especially at base	x
4 Ceilings					
a	Ceilings	acoustical ceiling tile	building	chipped, cracked, stained, and / or missing	x
b	Ceilings	wood	gymnasium	overall in good condition	
5 Flooring					
a	Flooring	VCT	building	cracked and / or separating	x

b	Flooring	carpet	classrooms, IMC, offices	overall in good condition	
c	Flooring	2" tile	toilet rooms / janitor closet / nurse's office	visibly stained and / or has stained grout	
d	Flooring	concrete	boiler / fan room	discolored and / or scuffed	x
e	Flooring	non-slip tile	kitchen / storage	cracked and / or stained	
f	Flooring	12" tile	main vestibule	overall in good condition	
g	Base	vinyl	building	peeling and / or missing in gymnasium	
h	Base	tile	toilet rooms	overall in good condition	
6 Miscellaneous					
a	Casework	laminate	building	laminate peeling along sinks	x
b	Lockers	metal	corridors	overall in good condition	
c	Bathroom Stall Partitions	metal / composite	toilet room	overall in good condition; few instances of rusting	
d	Drinking Fountains	metal / porcelain	corridors	overall in good condition

No.	Northwoods Comm. Elementary	Type / Material	Area / Location	Analysis	Identified in Plans
Building Exterior / Envelope					
7	Walls				
a	Foundation Walls	concrete	building	overall in good condition; few instances of cracking	x
b	Exterior Walls	brick	building	visibly stained, discolored, cracked, and / or chipped	x
c	Exterior Walls	painted concrete block	building	paint peeling, stained, and / or cracked	x
d	Exterior Walls	concrete block	columns / above windows	overall in good condition	
8	Windows				
a	Windows	aluminum	building	visibly faded, paint peeling, and / or rusting	see window analysis
b	Windows - Sills	stone	building	stained, and / or sealant peeling	x
c	Windows - Lintel	metal	building	visibly chipped, bent, and / or rusting	x
9	Doors				
a	Exterior Doors - Door / Frame	aluminum / aluminum storefront	building	scratched, fading, and / or rusted at base	see door analysis
b	Exterior Doors - Door / Frame	hollow metal / hollow metal	building	stained, discolored, and / or rusting	see door analysis

10	Roof				
a	Roof	-	building	see roof report	
b	Roof - Soffits	wood	gymnasium	chipping and paint peeling	x
c	Roof - Fascia	metal	building	overall in good condition	
11	Miscellaneous				
a	Column	metal	at door #2	rusted and unlevel	x
Site Development					
12	Asphalt / Paving				
a	Parking Lots	asphalt	S site	surface weathering and / or cracking	
b	Hard Surface Play Area	asphalt	N site	surface weathering and / or cracking	
13	Site Concrete				
a	Sidewalks	concrete	site	overall in good condition	
14	Greenspace				
a	Greenspace	grass	site	overall in good condition	
15	Playground				
a	Playground Equipment	metal / composite	W site	overall in good condition	
b	Playground Surface	woodchips	W site	overall in good condition

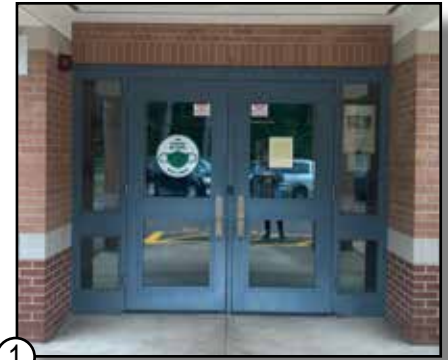
① ALUMINUM DOORS & ALUMINUM STOREFRONT

Northwoods Community Elementary			
No.	Door Type	Frame Type	Consider Replacement
1	Aluminum	Aluminum Storefront	x
2	Aluminum	Aluminum Storefront	x
3	Hollow Metal	Hollow Metal	x
4	Aluminum	Aluminum Storefront	x

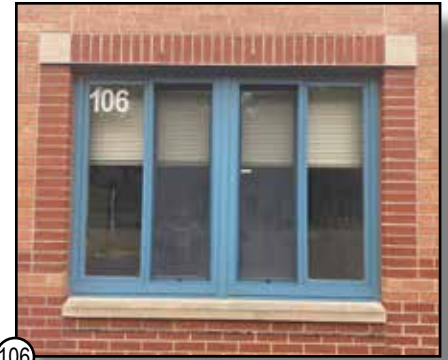
106 ALUMINUM W/ DOUBLE PANE

Northwoods Community Elementary		
No.	Window Type	Consider Replacement
112	Aluminum w/ Double Pane	
112A	Aluminum w/ Double Pane	
109	Aluminum w/ Double Pane	
107	Aluminum w/ Double Pane	
106	Aluminum w/ Double Pane	
101	Aluminum w/ Double Pane	x paint peeling, frame rusted
101A	Aluminum w/ Double Pane	
100	Aluminum w/ Double Pane	
102	Aluminum w/ Double Pane	
108	Aluminum w/ Double Pane	
123	Aluminum w/ Double Pane	
123A	Glass Block	
122	Aluminum w/ Double Pane	
116	Aluminum w/ Double Pane	
114	Aluminum w/ Double Pane

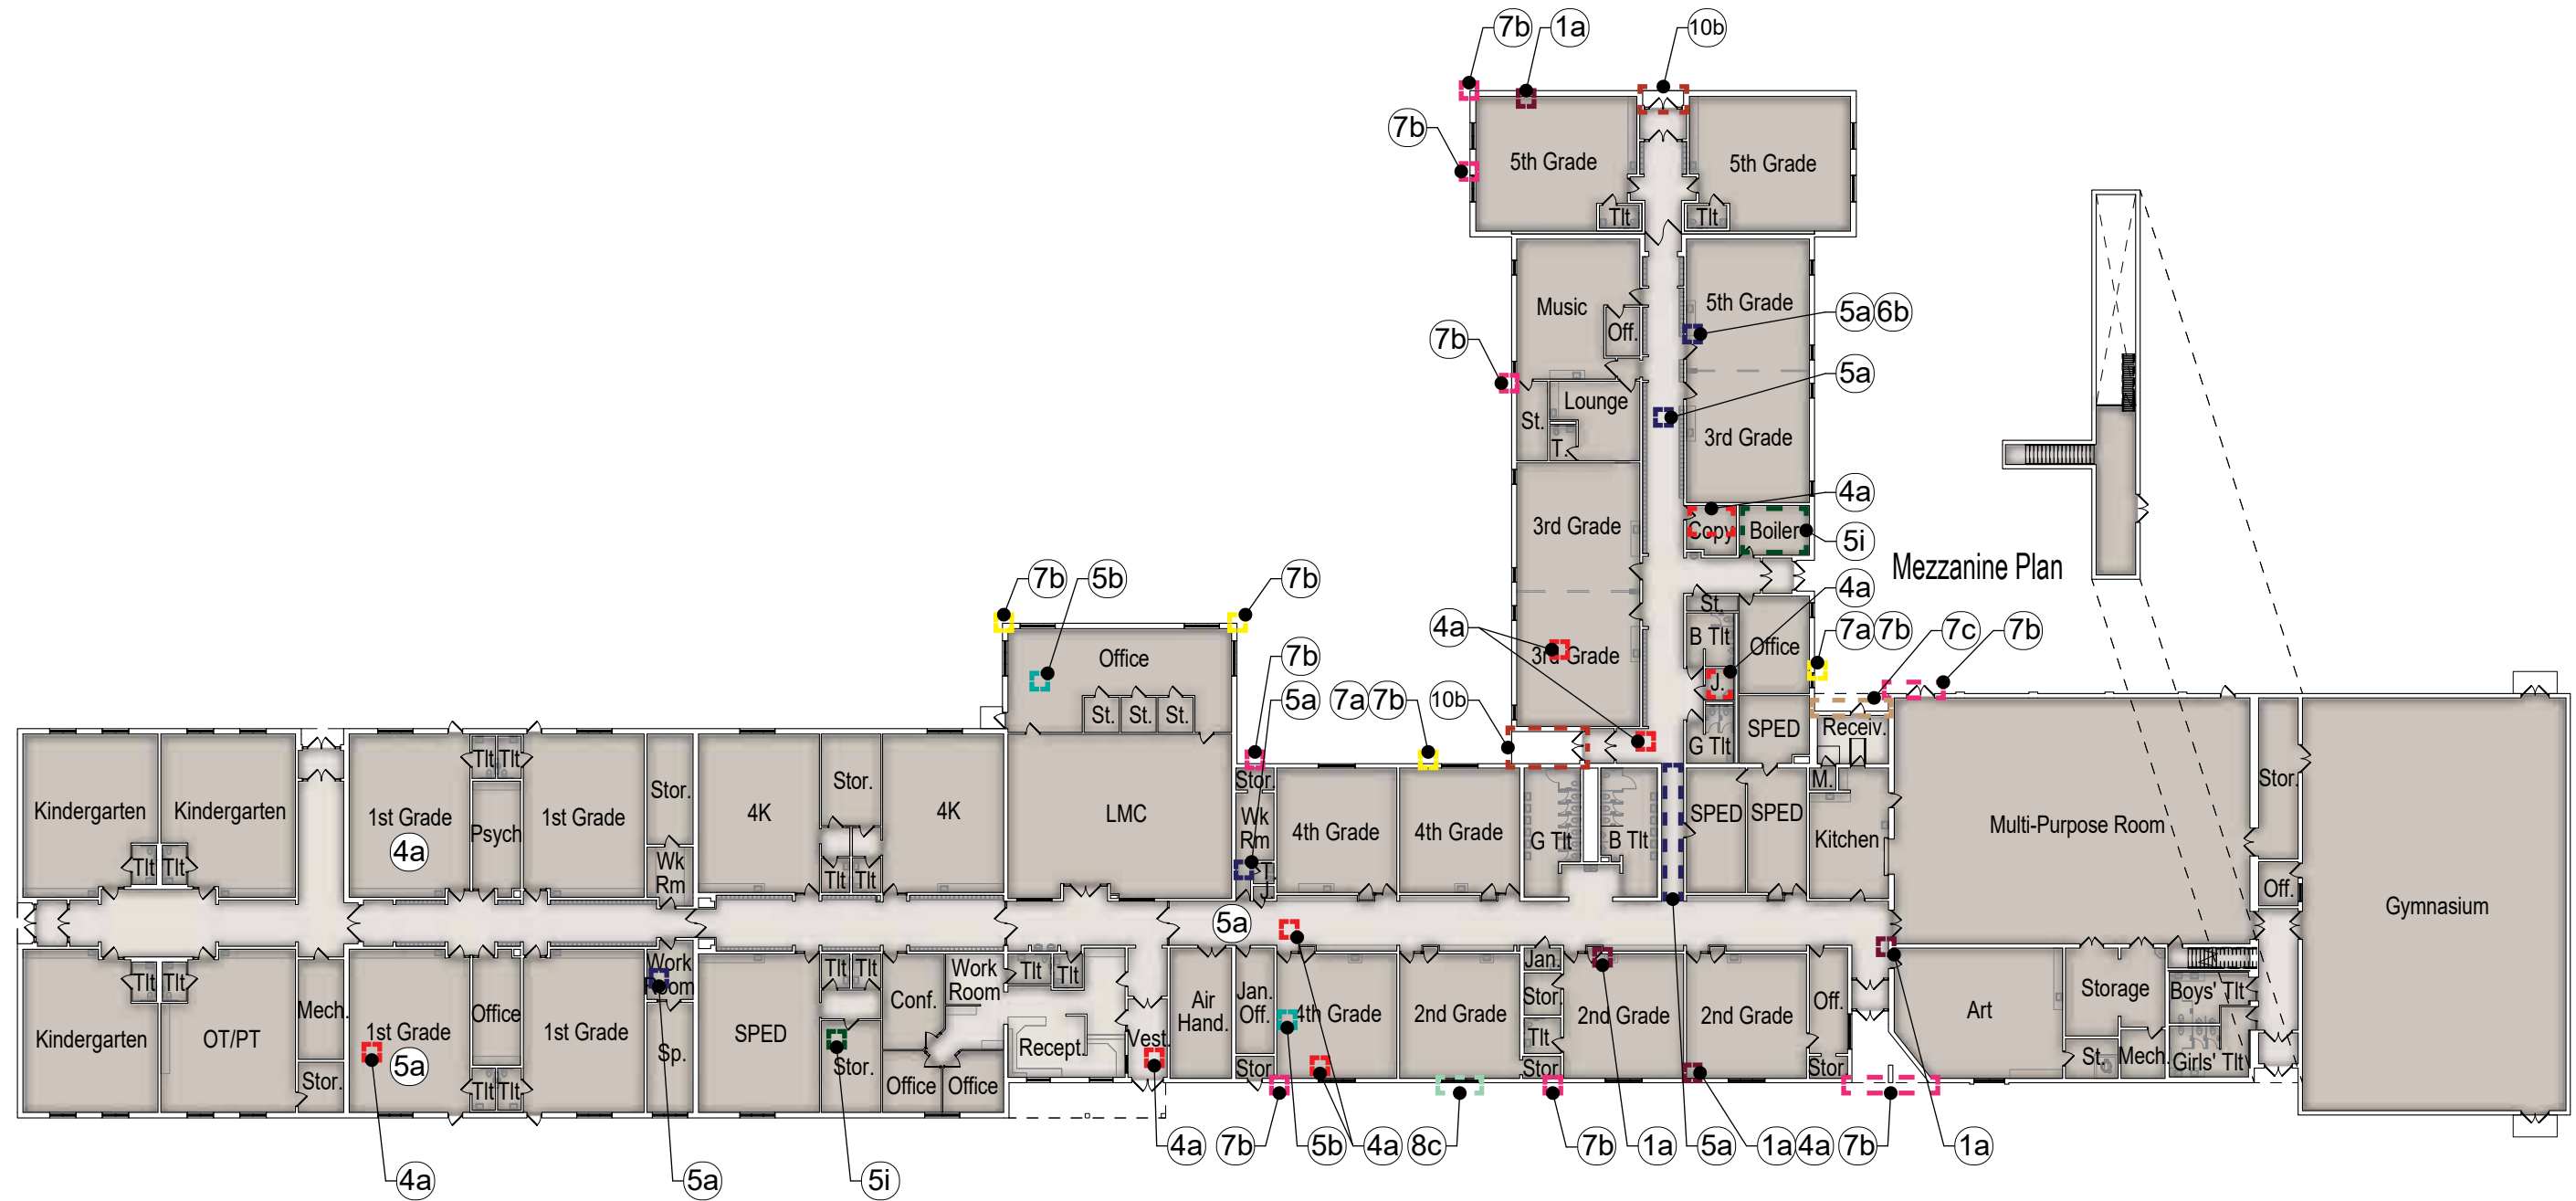
FIRST FLOOR PLAN
not to scale

No.	Crescent Elementary	Type / Material	Area / Location	Analysis	Identified in Plans
Infrastructure Improvement					
Building Interior					
1	Walls				
a	Walls	concrete block	building	overall in good condition; few instances of staining and / or cracking	x
b	Walls	fabric accordion partition	classrooms	overall in good condition; difficult to operate	
c	Walls	gypsum	building	overall in good condition; few instances of scuffs	
d	Walls	tile	toilet rooms, corridors	overall in good condition	
2	Window Interior & Openings				
a	Interior Window	wood	building	overall in good condition	
b	Interior Window Sills	laminated	building	overall in good condition	
3	Interior Doors				
a	Interior Doors - Door / Frame	wood / hollow metal	building	overall in good condition	
b	Interior Doors - Door / Frame	wood w/ grille / hollow metal	building	overall in good condition	
4	Ceilings				
a	Ceilings	acoustical ceiling tile	building	some instances of bowing, chipping, staining, and / or loose tracks	x

b	Ceilings	metal deck	mechanical spaces / gymnasium	overall in good condition	
5	Flooring				
a	Flooring	VCT	building	some instances of staining, cracking, separation, and / or bubbling	x
b	Flooring	carpet	building	overall in good condition; few instances of staining	x
c	Flooring	carpet tile	offices	overall in good condition	
d	Flooring	2" tile	toilet rooms / corridor	overall in good condition	
e	Flooring	6" tile	toilet rooms	overall in good condition	
f	Flooring	12" tile	toilet rooms	overall in good condition	
g	Flooring	quarry tile	kitchen	overall in good condition	
h	Flooring	rubber	gymnasium	overall in good condition	
i	Flooring	concrete	mechanical / janitor / storage	visibly stained, cracked, or chipped	x
j	Base	vinyl	building	overall in good condition	
k	Base	tile	toilet rooms / locker rooms	overall in good condition	
6	Miscellaneous				
a	Casework / Coat Hooks	wood veneer / laminate	corridors	overall in good condition

b	Casework	wood veneer / laminate	classrooms	overall in good condition; some instances of missing laminate	x
c	Lockers	metal	corridors / offices	overall in good condition	
d	Bathroom Stall Partitions	metal / composite	toilet room	overall in good condition	
e	Cubbies	wood veneer	kindergarten classroom	overall in good condition

No.	Crescent Elementary	Type / Material	Area / Location	Analysis	Identified in Plans
Building Exterior / Envelope					
7	Walls				
a	Foundation Walls	concrete	building	overall in good condition; few instances of cracking	x
b	Exterior Walls	brick	building	some instances of cracking, chipping, and / or staining	x
c	Exterior Walls	painted concrete block	building	overall in good condition; few instances of cracking / chipping in block, paint chipping	x
d	Exterior Walls	metal paneling	building	overall in good condition	
8	Windows				
a	Windows	aluminum	building	visibly faded and discolored, sealant peeling, and / or some instances of worn screens	see window analysis
b	Windows - Sills	metal	building	overall in good condition	
c	Windows - Lintel	metal	building	overall in good condition; few instances of bent lintels	x
9	Doors				
a	Exterior Doors - Door / Frame	aluminum / aluminum storefront	building	overall in good condition	see door analysis

b	Exterior Doors - Door / Frame	hollow metal / hollow metal	building	overall in good condition; few instances of fading / discoloration	see door analysis
10	Roof				
a	Roof	-	building	see roof report	
b	Roof - Soffits	metal	door overhangs	overall in good condition; few instances of rusting and / or discoloring	x
d	Roof - Fascia	metal	building	overall in good condition	
11	Miscellaneous				
a	Exhausts	metal	building	overall in good condition	
Site Development					
12	Asphalt / Paving				
a	Parking Lots	asphalt	SW site	surface weathering and / or cracking	
b	Hard Surface Play Area	asphalt	W site	some instances of surface weathering and / or cracking	
13	Site Concrete				
a	Sidewalks	concrete	site	overall in good condition	
b	Door Stoops	concrete	site	overall in good condition; some instances of cracking	
14	Greenspace				
a	Greenspace	grass	site	overall in good condition	
15	Playground				
a	Playground Equipment	metal / composite	W site	overall in good condition

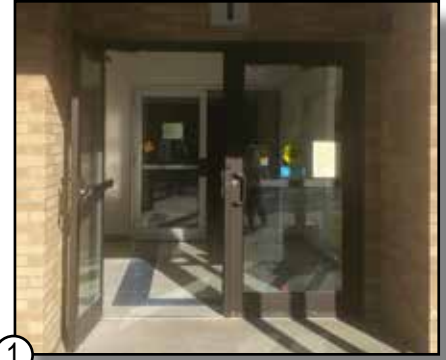
1 ALUMINUM DOORS & ALUMINUM STOREFRONT

Crescent Elementary			
No.	Door Type	Frame Type	Consider Replacement
1	Aluminum	Aluminum Storefront	
2	Aluminum	Aluminum Storefront	
3	Aluminum	Aluminum Storefront	
4	Aluminum	Aluminum Storefront	
5	Aluminum	Aluminum Storefront	
6	Aluminum	Aluminum Storefront	
7	Hollow Metal	Hollow Metal	x
8	Aluminum	Aluminum Storefront	
9	Aluminum	Aluminum Storefront	
10	Aluminum	Aluminum Storefront	
11	Hollow Metal	Hollow Metal	
12	Hollow Metal	Hollow Metal	x
13	Hollow Metal	Hollow Metal	x
13A	Hollow Metal	Hollow Metal	
13B	Hollow Metal	Hollow Metal	
13C	Aluminum	Aluminum Storefront	
14	Aluminum	Aluminum Storefront	x
14A	Hollow Metal	Hollow Metal

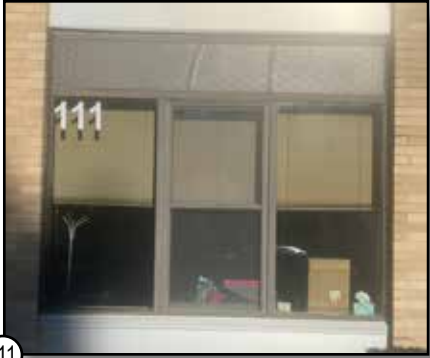
111 ALUMINUM W/ DOUBLE PANE

Crescent Elementary		
No.	Window Type	Consider Replacement
111	Aluminum w/ Double Pane	
109	Aluminum w/ Double Pane	
107	Aluminum w/ Double Pane	x discolored, paint peeling
105	Aluminum w/ Double Pane	
103	Aluminum w/ Double Pane	
101	Aluminum w/ Double Pane	x discolored
208	Aluminum w/ Double Pane	
208A	Aluminum w/ Double Pane	
214	Aluminum w/ Double Pane	x torn screens
216	Aluminum w/ Double Pane	
218	Aluminum w/ Double Pane	
219	Aluminum w/ Double Pane	
219A	Aluminum w/ Double Pane	
217	Aluminum w/ Double Pane	
209	Aluminum w/ Double Pane	
207	Aluminum w/ Double Pane	
108	Aluminum w/ Double Pane	
110	Aluminum w/ Double Pane	
110A	Aluminum w/ Double Pane	
118A	Aluminum w/ Double Pane	
120	Aluminum w/ Double Pane	
122	Aluminum w/ Double Pane	
126	Aluminum w/ Double Pane	paint peeling
130	Aluminum w/ Double Pane	
132	Aluminum w/ Double Pane	
134	Aluminum w/ Double Pane	
136	Aluminum w/ Double Pane	
135	Aluminum w/ Double Pane

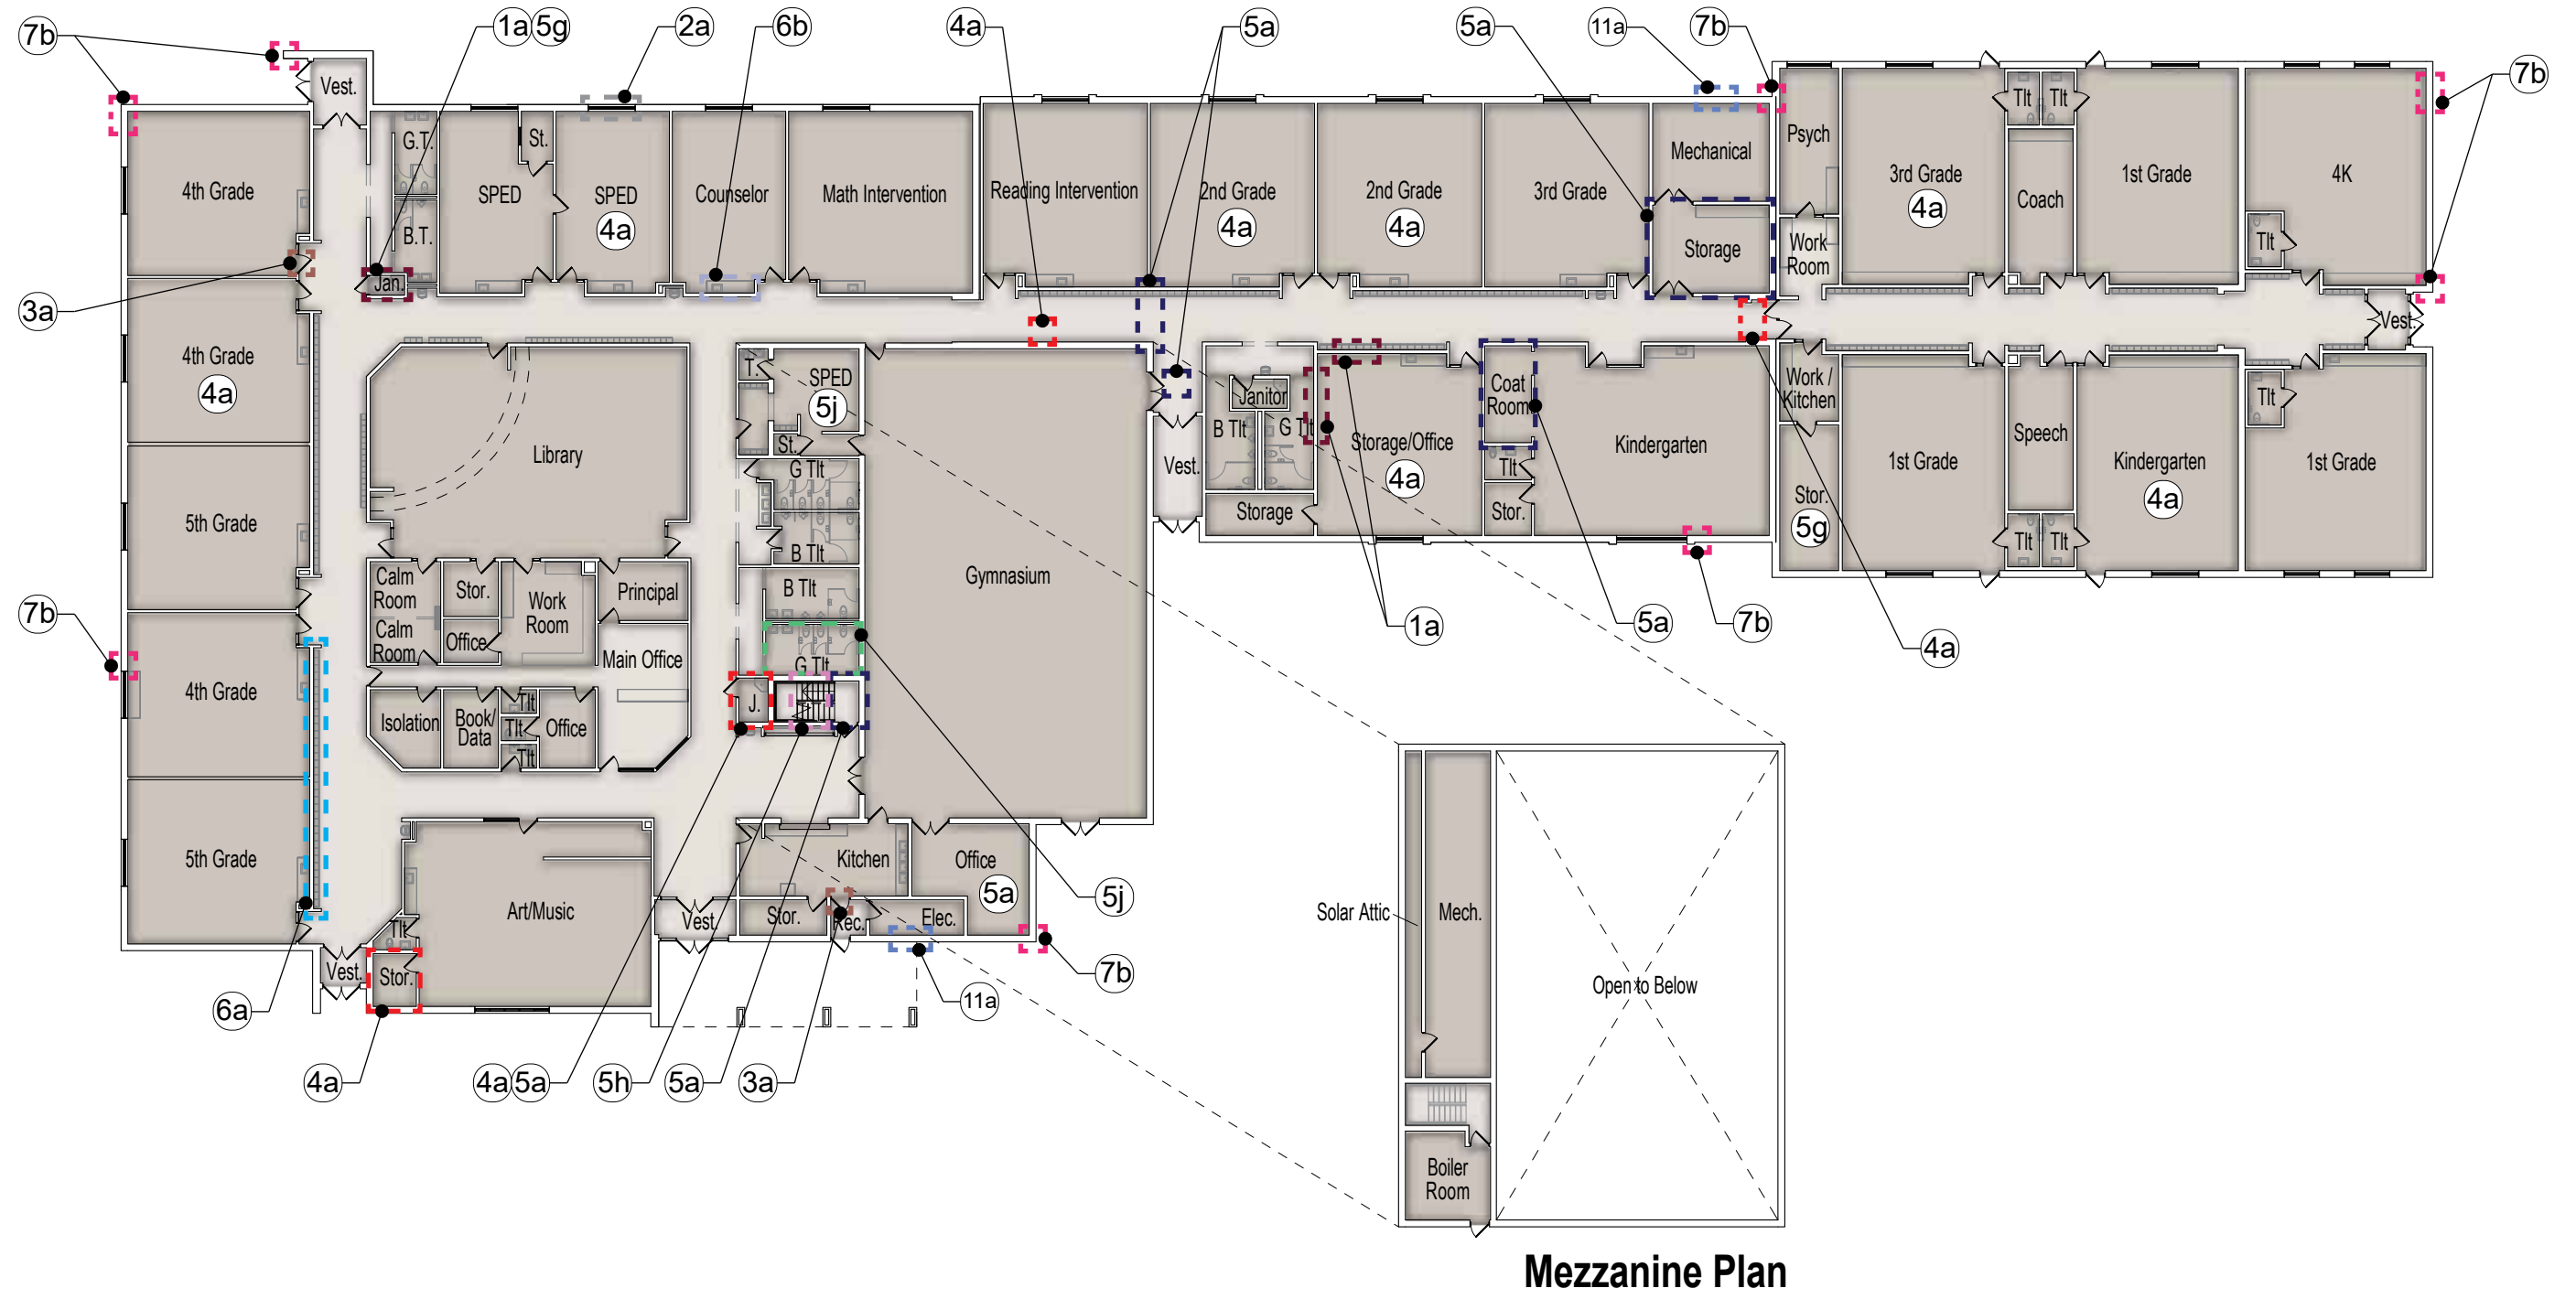
FIRST FLOOR PLAN
not to scale

No.	Pelican Elementary	Type / Material	Area / Location	Analysis	Identified in Plans
Infrastructure Improvement					
Building Interior					
1	Walls				
a	Walls	concrete block	building	overall in good condition; few instances of chipping, staining, holes	x
b	Walls	fabric accordion partition	library	overall in good condition	
c	Walls	gypsum	building	overall in good condition; few instances of scuffs / marks	
d	Walls	tile	toilet rooms, corridors	visibly stained, chipped, and / or has stained grout	
2	Window Interior & Openings				
a	Interior Window	wood	building	overall in good condition; instances of broken hardware	x
b	Interior Window Sills	laminated	building	overall in good condition; few instances of chipping, broken caulking	
3	Interior Doors				
a	Interior Doors - Door / Frame	wood / hollow metal	building	overall in good condition; some instances of chipping / peeling on frame	x
b	Interior Doors - Door / Frame	wood w/ grille / hollow metal	building	overall in good condition

4	Ceilings				
a	Ceilings	acoustical ceiling tile	building	some instances of bowing, chipping, and / or staining	x
b	Ceilings	metal deck	mechanical spaces / gymnasium	overall in good condition	
5	Flooring				
a	Flooring	VCT	building	some instances of staining, cracking, and separation	x
b	Flooring	carpet	building	overall in good condition	
c	Flooring	2" tile	toilet rooms	visibly stained and / or has stained grout	
d	Flooring	quarry tile	kitchen	visibly stained and / or has stained grout	
e	Flooring	rubber	gymnasium	overall in good condition; some signs of wear	
f	Flooring	raised rubber	vestibule	visibly worn and discolored / stained	
g	Flooring	concrete	mechanical / janitor / electrical rooms	visibly stained, cracked, or chipped	x
h	Stair Treads	metal	mechanical mezzanine	visibly scratched, stained, and rusted	x
i	Base	vinyl	building	overall in good condition; some instances of damage / missing boards

j	Base	tile	toilet rooms / locker rooms	visibly chipped, stained, and / or has stained grout	x
6	Miscellaneous				
a	Casework	wood	corridors	overall in good condition; some signs of wear, dated	x

No.	Pelican Elementary	Type / Material	Area / Location	Analysis	Identified in Plans
Infrastructure Improvement					
Building Interior					
b	Casework	wood veneer / laminate	classrooms	overall in good condition; some signs of wear / damage	
c	Lockers	metal	corridors / offices	overall in good condition	
d	Bathroom Stall Partitions	metal / composite	toilet room	overall in good condition; few instances of paint chipping / rusting	
e	Railings	metal	mechanical mezzanine	visibly scratched and / or has paint peeling	
f	Cubbies	wood veneer	kindergarten classroom	overall in good condition	
Building Exterior / Envelope					
7 Walls					
a	Foundation Walls	concrete	building	overall in good condition	
b	Exterior Walls	painting concrete block	building	overall in good condition; few instances of cracking / chipping in block, paint chipping	x
8 Windows					
a	Windows	aluminum	building	visibly faded and discolored, some instances of torn screens	see window analysis

b	Windows - Sills	metal	building	visibly faded and discolored	
c	Windows - Lintel	metal	building	overall in good condition	
9 Doors					
a	Exterior Doors - Door / Frame	aluminum / aluminum storefront	building	overall in good condition; few instances of scratching / fading	see door analysis
b	Exterior Doors - Door / Frame	hollow metal / hollow metal	building	overall in good condition; few instances of fading / discoloration	see door analysis
10 Roof					
a	Roof	-	building	see roof report	
b	Roof - Soffits	vinyl	door overhangs	overall in good condition	
c	Roof - Soffits	metal	front entry overhang	overall in good condition	
d	Roof - Fascia	metal	building	overall in good condition	
11 Miscellaneous					
a	Exhausts	metal	building	some instances of paint chipping and rust	x
Site Development					
12 Asphalt / Paving					
a	Parking Lots	asphalt	E site	surface weathering and / or cracking	
b	Hard Surface Play Area	asphalt	N site	some instances of surface weathering and / or cracking

c	Pavers	stone	garden area	overall in good condition	
13 Site Concrete					
a	Sidewalks	concrete	site	visibly cracking and / or stained	
b	Door Stoops	concrete	site	overall in good condition; some instances of cracking and / or staining	
c	Stairs	concrete	site	overall in good condition	
14 Greenspace					
a	Greenspace	grass	site	overall in good condition	
15 Playground					
a	Playground Equipment	metal / composite	W site	overall in good condition	
b	Playground Surface	woodchips	W site	overall in good condition

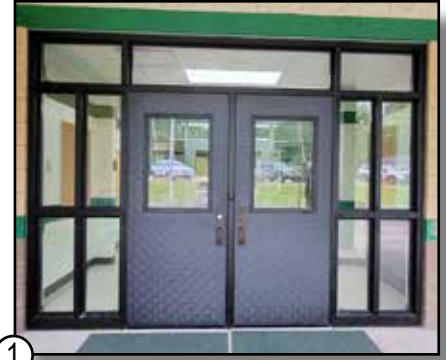
① FRP DOORS & ALUMINUM STOREFRONT

Pelican Elementary			
No.	Door Type	Frame Type	Consider Replacement
1	Fiber Reinforced Plastic	Aluminum Storefront	
2	Fiber Reinforced Plastic	Aluminum Storefront	
3	Fiber Reinforced Plastic	Aluminum Storefront	
4	Aluminum	Aluminum	
5	Aluminum	Aluminum	
6	Aluminum	Aluminum Storefront	
7	Aluminum	Aluminum	x
8	Aluminum	Aluminum	x
9	Aluminum	Aluminum Storefront	
10	Hollow Metal	Hollow Metal	x
11	Hollow Metal	Hollow Metal	x
12	Hollow Metal	Hollow Metal

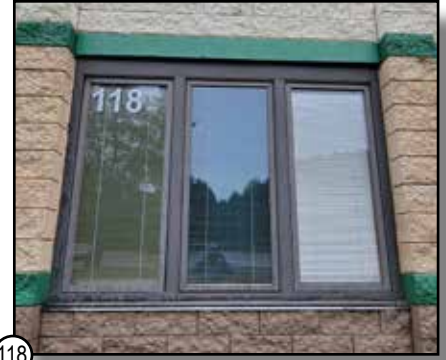
118 ALUMINUM W/ DOUBLE PANE

Pelican Elementary		
No.	Window Type	Consider Replacement
111	Aluminum w/ Double Pane	
115	Aluminum w/ Double Pane	
116	Aluminum w/ Double Pane	
117	Aluminum w/ Double Pane	
118	Aluminum w/ Double Pane	
119	Aluminum w/ Double Pane	
126	Aluminum w/ Double Pane	
127	Aluminum w/ Double Pane	
128	Aluminum w/ Double Pane	
129	Aluminum w/ Double Pane	
130	Aluminum w/ Double Pane	x discolored, sealant cracking, frame dented
131	Aluminum w/ Double Pane	
132	Aluminum w/ Double Pane	x discolored, sealant cracking
133	Aluminum w/ Double Pane	x discolored, sealant cracking
150A	Aluminum w/ Double Pane	
152	Aluminum w/ Double Pane	x discolored, torn screen
156	Aluminum w/ Double Pane	x discolored, screens worn/torn
158	Aluminum w/ Double Pane	
159	Aluminum w/ Double Pane	
157	Aluminum w/ Double Pane	
153	Aluminum w/ Double Pane	
135	Aluminum w/ Double Pane	
136	Aluminum w/ Double Pane

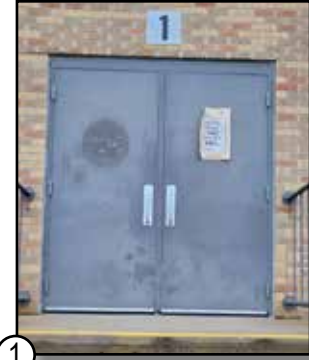
① HOLLOW METAL DOORS & HOLLOW METAL FRAME

Central Elementary			
No.	Door Type	Frame Type	Consider Replacement
1	Hollow Metal	Hollow Metal	x
2	Hollow Metal	Hollow Metal	x
3	Fiber Reinforced Plastic	Aluminum	
4	Hollow Metal	Hollow Metal	x
5	Fiber Reinforced Plastic	Aluminum	
6	Hollow Metal	Hollow Metal	x
8	Aluminum	Aluminum Storefront	
9	Hollow Metal	Hollow Metal

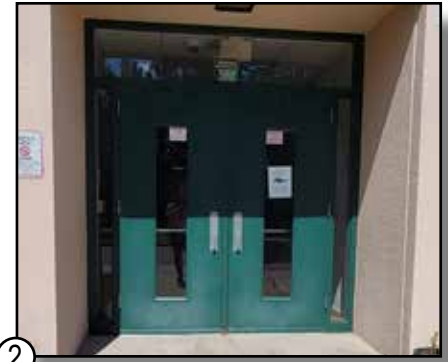
2 HOLLOW METAL DOORS & HOLLOW METAL STOREFRONT

James Williams Middle School			
No.	Door Type	Frame Type	Consider Replacement
1	Fiber Reinforced Plastic	Aluminum Storefront	
2	Hollow Metal	Hollow Metal Storefront	x
3	Hollow Metal	Hollow Metal Storefront	x
4	Hollow Metal	Hollow Metal Storefront	x
5	Hollow Metal	Hollow Metal Storefront	
6	Hollow Metal	Hollow Metal Storefront	
7	Hollow Metal	Hollow Metal Storefront	
8	Fiber Reinforced Plastic	Hollow Metal Storefront	
9	Fiber Reinforced Plastic	Hollow Metal Storefront	
10	Fiber Reinforced Plastic	Hollow Metal	x
11	Hollow Metal	Hollow Metal	
12	Fiber Reinforced Plastic	Aluminum Storefront	
13	Fiber Reinforced Plastic	Aluminum Storefront	
14	Fiber Reinforced Plastic	Aluminum Storefront	x
15	Hollow Metal	Hollow Metal	x
16	Fiber Reinforced Plastic	Aluminum Storefront	
17	Fiber Reinforced Plastic	Aluminum	
18	Fiber Reinforced Plastic	Aluminum Storefront

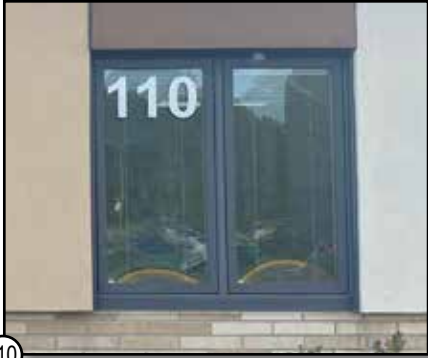
110 ALUMINUM W/ DOUBLE PANE

111	Aluminum w/ Double Pane	
113	Aluminum w/ Double Pane	
112	Aluminum w/ Double Pane	
110	Aluminum w/ Double Pane	x glass cracked
109	Aluminum w/ Double Pane	
107	Aluminum w/ Double Pane	
507	Aluminum w/ Double Pane	
508C	Aluminum w/ Double Pane	
508B	Aluminum w/ Double Pane	
508	Aluminum w/ Double Pane	
244	Aluminum w/ Double Pane	
246	Aluminum w/ Double Pane	
248	Aluminum w/ Double Pane	
243	Aluminum w/ Double Pane	
241	Aluminum w/ Double Pane	
239	Aluminum w/ Double Pane	
237	Aluminum w/ Double Pane	
233	Aluminum w/ Double Pane	
203	Aluminum w/ Double Pane	
205	Aluminum w/ Double Pane	
207	Aluminum w/ Double Pane	
209	Aluminum w/ Double Pane	
211	Aluminum w/ Double Pane	
213	Aluminum w/ Double Pane	
215	Aluminum w/ Double Pane	
217	Aluminum w/ Double Pane
