STUDY DOCUMENT

SCHOOL DISTRICT OF RHINELANDER

Bray Associates Architects, Inc.

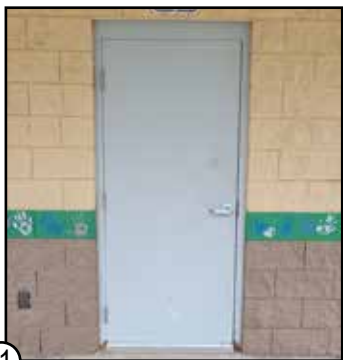
⑪ HOLLOW METAL DOOR & HOLLOW METAL FRAME

Pelican Elementary			
No.	Door Type	Frame Type	Consider Replacement
1	Fiber Reinforced Plastic	Aluminum Storefront	
2	Fiber Reinforced Plastic	Aluminum Storefront	
3	Fiber Reinforced Plastic	Aluminum Storefront	
4	Aluminum	Aluminum	
5	Aluminum	Aluminum	
6	Aluminum	Aluminum Storefront	
7	Aluminum	Aluminum	x
8	Aluminum	Aluminum	x
9	Aluminum	Aluminum Storefront	
10	Hollow Metal	Hollow Metal	x
11	Hollow Metal	Hollow Metal	x
12	Hollow Metal	Hollow Metal

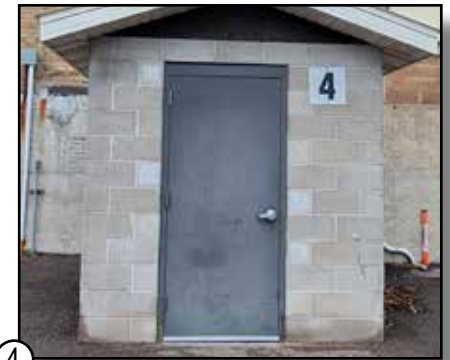
④ HOLLOW METAL DOORS & HOLLOW METAL FRAME

Central Elementary			
No.	Door Type	Frame Type	Consider Replacement
1	Hollow Metal	Hollow Metal	x
2	Hollow Metal	Hollow Metal	x
3	Fiber Reinforced Plastic	Aluminum	
4	Hollow Metal	Hollow Metal	x
5	Fiber Reinforced Plastic	Aluminum	
6	Hollow Metal	Hollow Metal	x
8	Aluminum	Aluminum Storefront	
9	Hollow Metal	Hollow Metal

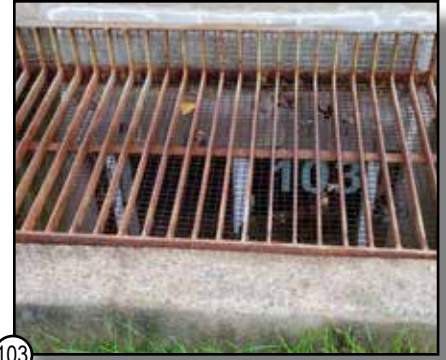
103 ALUMINUM W/ DOUBLE PANE

Central Elementary		
No.	Window Type	Consider Replacement
102A	Aluminum w/ Double Pane	grate rusted
103	Aluminum w/ Double Pane	grate rusted
102	Aluminum w/ Double Pane	grate rusted
104	Glass Block	
105	Glass Block	
106	Aluminum w/ Double Pane	x discolored, grate rusted, frame rusted
198	Aluminum w/ Double Pane	
199	Aluminum w/ Double Pane	
200	Aluminum w/ Double Pane	
201	Aluminum w/ Double Pane	x discolored, frame worn
203	Aluminum w/ Double Pane	x discolored, frame dented / worn
205	Aluminum w/ Double Pane	x discolored, frame scratched / worn
309A	Aluminum w/ Double Pane	x frame dented / scratched, screen torn
309B	Aluminum w/ Double Pane	x filled in
309	Aluminum w/ Double Pane	
315A	Aluminum w/ Double Pane	
315B	Aluminum w/ Double Pane	x filled in
315	Aluminum w/ Double Pane	
318A	Aluminum w/ Double Pane	
318B	Aluminum w/ Double Pane	x filled in
318	Aluminum w/ Double Pane	
319A	Aluminum w/ Double Pane	x discolored, frame rusted / worn

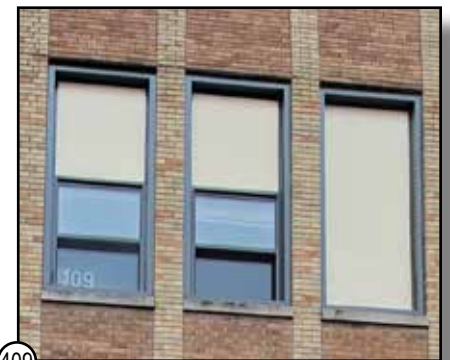
409 ALUMINUM W/ DOUBLE PANE

Central Elementary		
No.	Window Type	Consider Replacement
405	Aluminum w/ Double Pane	
406A	Aluminum w/ Double Pane	
406B	Aluminum w/ Double Pane	x filled in
406	Aluminum w/ Double Pane	
409A	Aluminum w/ Double Pane	x discolored, sealant cracking
409B	Aluminum w/ Double Pane	x filled in
409	Aluminum w/ Double Pane	
411A	Aluminum w/ Double Pane	
411B	Aluminum w/ Double Pane	x filled in
411	Aluminum w/ Double Pane	
414	Aluminum w/ Double Pane	
413A	Aluminum w/ Double Pane	
413	Aluminum w/ Double Pane	
412	Aluminum w/ Double Pane	x discolored, frame worn
410	Aluminum w/ Double Pane	x discolored, frame worn
410A	Aluminum w/ Double Pane	x filled in
407A	Aluminum w/ Double Pane	x discolored, frame worn
407B	Aluminum w/ Double Pane	x filled in
407	Aluminum w/ Double Pane	x discolored, frame worn
405	Aluminum w/ Double Pane	x discolored, frame worn
403	Aluminum w/ Double Pane	x discolored, frame worn
401A	Aluminum w/ Double Pane

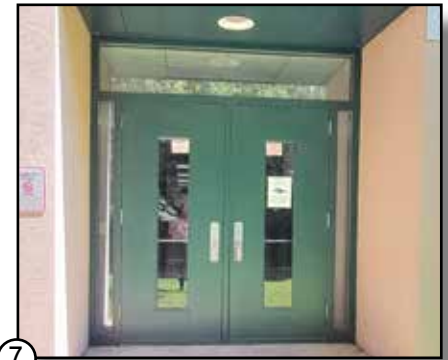
7 HOLLOW METAL DOORS & HOLLOW METAL STOREFRONT

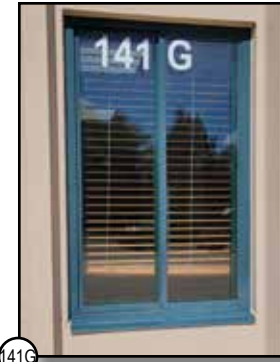
James Williams Middle School			
No.	Window Type	Consider Replacement	
143D	Aluminum w/ Double Pane		
141G	Aluminum w/ Double Pane	x	discolored, glass worn / damaged
141F	Aluminum w/ Double Pane		
141E	Aluminum w/ Double Pane		
141D	Aluminum w/ Double Pane		
105	Aluminum w/ Double Pane	x	discolored, screens worn, paint chipping
155	Aluminum w/ Double Pane	x	discolored, frame worn
111	Aluminum w/ Double Pane		
112	Aluminum w/ Double Pane		
113	Aluminum w/ Double Pane		
114	Aluminum w/ Double Pane		
118A	Aluminum w/ Double Pane	x	frame dented / bent
118	Aluminum w/ Double Pane		
119	Aluminum w/ Double Pane		
123	Aluminum w/ Double Pane		
124	Aluminum w/ Double Pane		
128A	Aluminum w/ Double Pane	x	frame dented / bent
128	Aluminum w/ Double Pane		
129A	Aluminum w/ Double Pane	x	frame dented, paint peeling
129	Aluminum w/ Double Pane	x	frame bent, paint peeling
130	Aluminum w/ Double Pane	x	paint bubbling / chipping

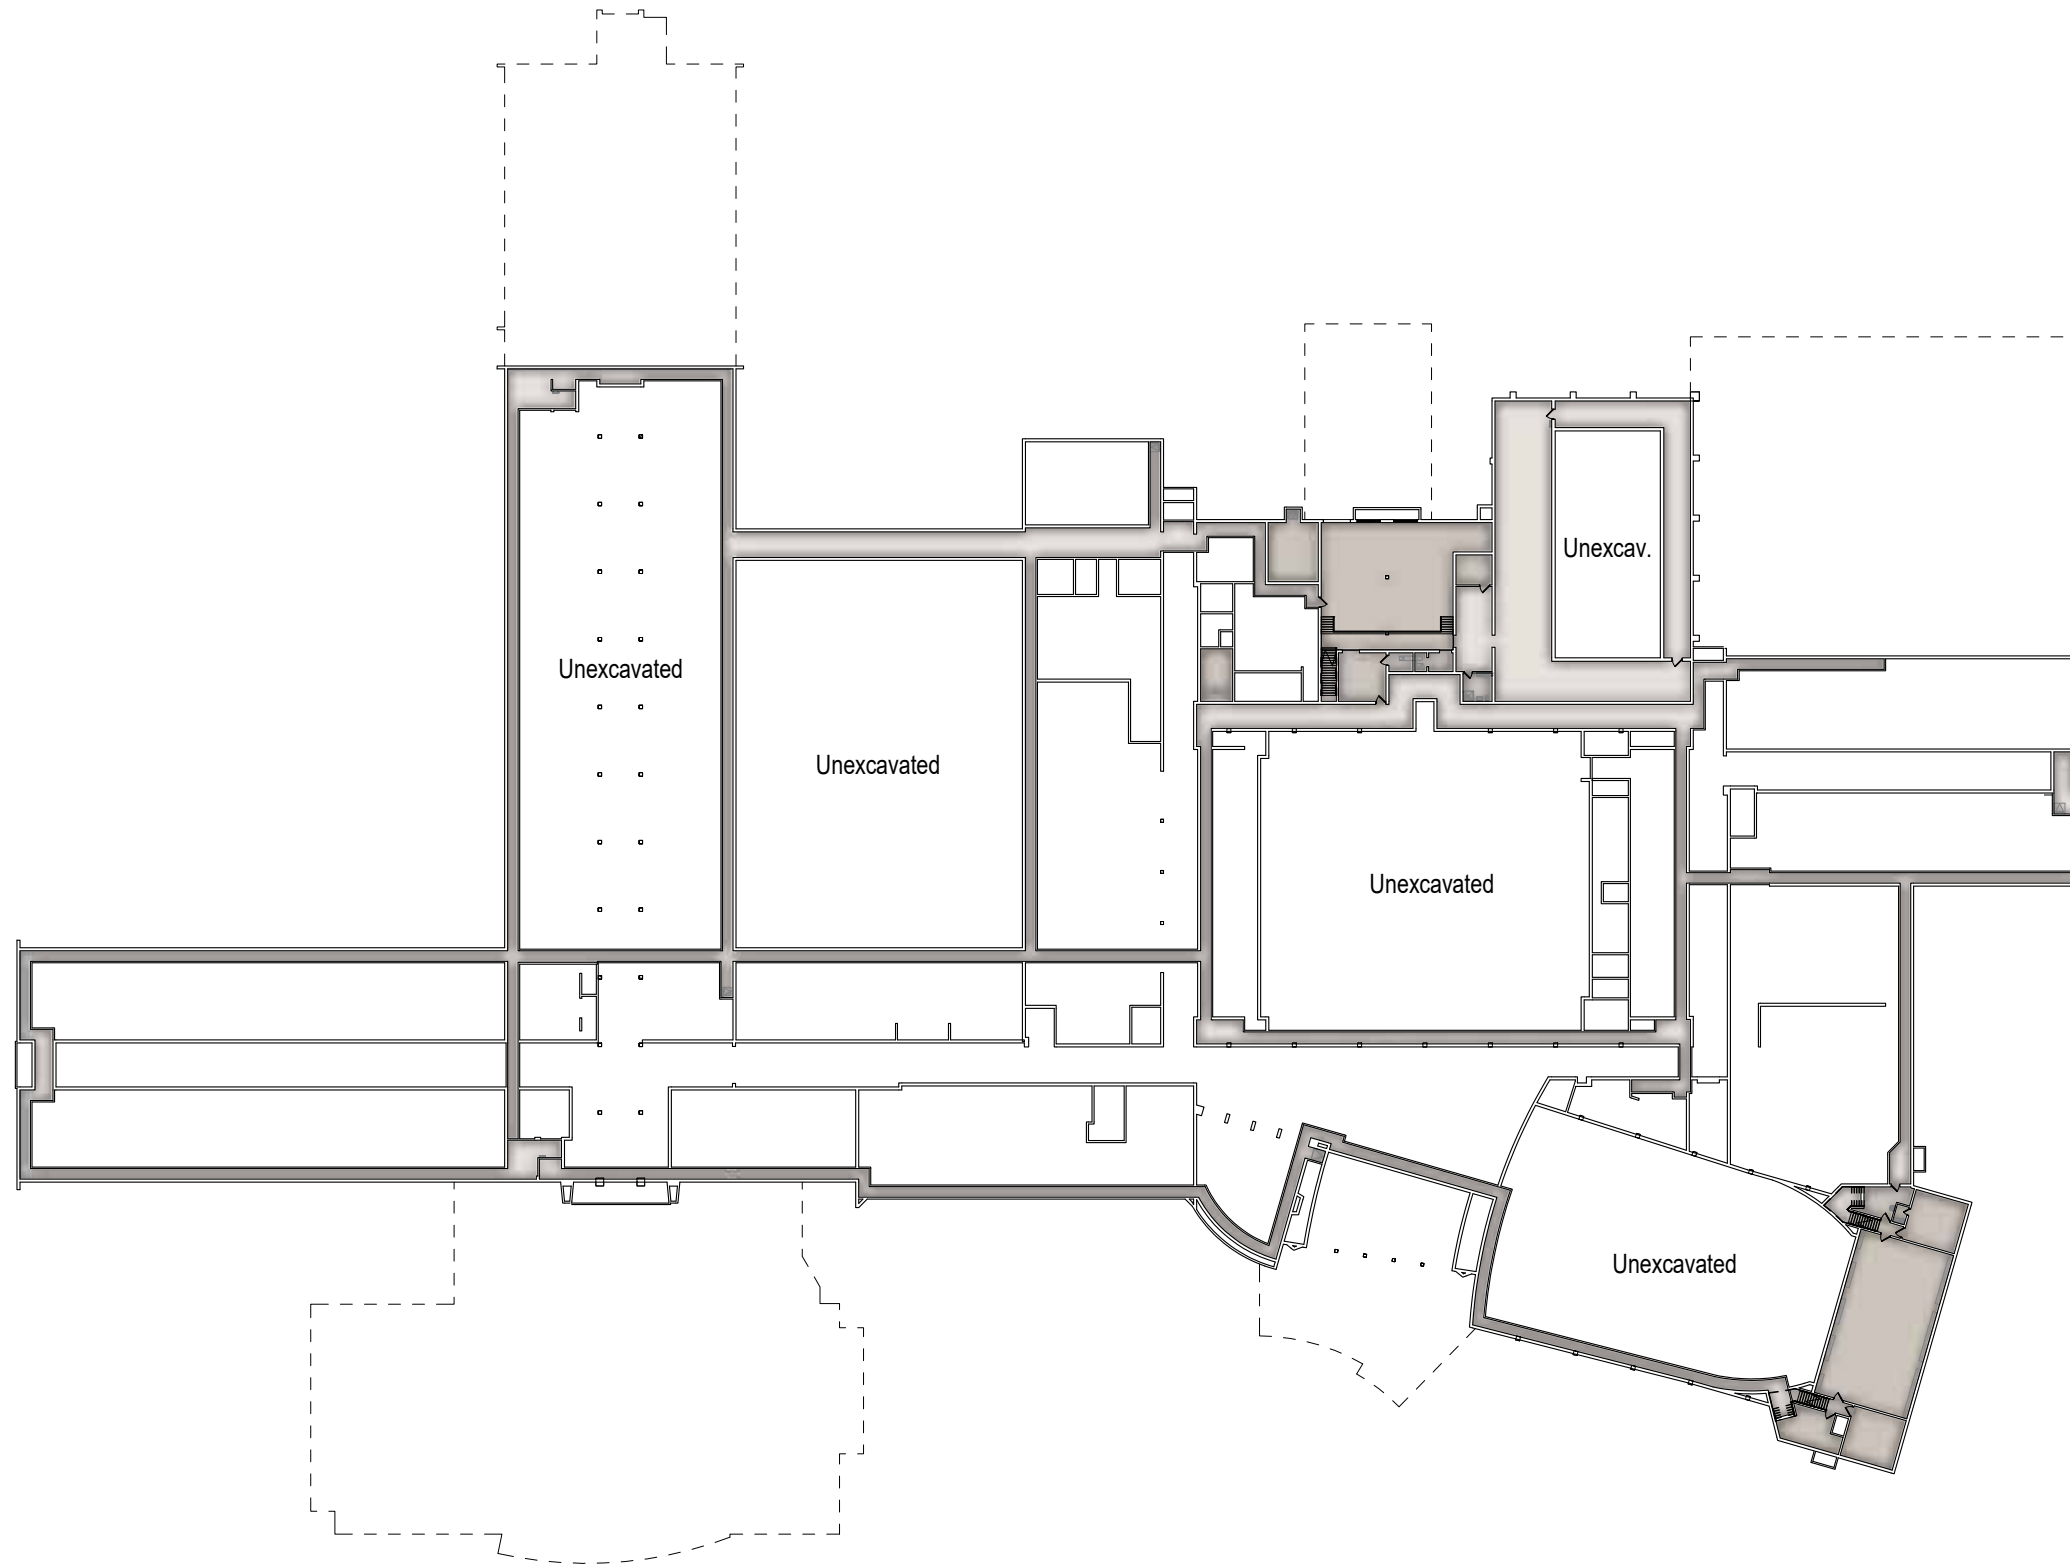
LOWER LEVEL PLAN
not to scale

**Note: Due to flooding, limited data could be found on the lower level.

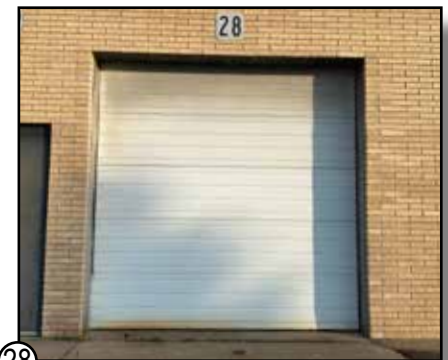
28 ROLL-UP DOOR

Rhineland High School			
No.	Door Type	Frame Type	Consider Replacement
1	Aluminum	Aluminum Storefront	
1A	Hollow Metal	Hollow Metal	x
2	Aluminum	Aluminum Storefront	
3	Aluminum	Aluminum Storefront	
4	Aluminum	Aluminum Storefront	
5	Aluminum	Aluminum Storefront	
6	Aluminum	Aluminum Storefront	
7	Fiber Reinforced Plastic	Aluminum	
9	Hollow Metal	Hollow Metal	
10	Aluminum	Aluminum Storefront	
11	Aluminum	Aluminum Storefront	
12	Fiber Reinforced Plastic	Aluminum	
13	Fiber Reinforced Plastic	Aluminum Storefront	
14	Hollow Metal	Hollow Metal	x
15	Hollow Metal	Hollow Metal	x
16	Hollow Metal	Hollow Metal	x
17	Roll-up Door	N/A	x
18	Fiber Reinforced Plastic	Aluminum	
19	Aluminum	Aluminum Storefront	
21	Hollow Metal	Hollow Metal	x
22	Fiber Reinforced Plastic	Aluminum Storefront	
23	Roll-up Door	N/A	
24	Hollow Metal	Aluminum	x
25	Roll-up Door	N/A	
26	Roll-up Door	N/A	
27	Hollow Metal	Aluminum	x
28	Roll-up Door	N/A	x
29	Hollow Metal	Hollow Metal	x

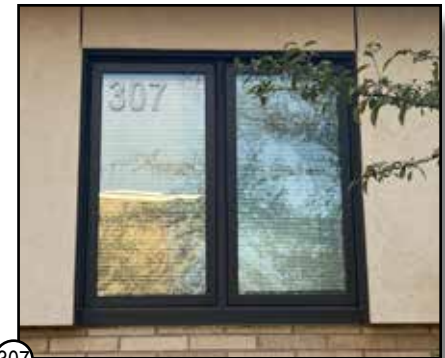
307 ALUMINUM W/ DOUBLE PANE

Rhineland High School		
No.	Window Type	Consider Replacement
104	Aluminum w/ Double Pane	
102	Aluminum w/ Double Pane	
400	Aluminum w/ Double Pane	
400A	Aluminum w/ Double Pane	
301	Aluminum w/ Double Pane	
307	Aluminum w/ Double Pane	sealant peeling
114	Aluminum w/ Double Pane	
114A	Aluminum w/ Double Pane	x filled in
114B	Aluminum w/ Double Pane	
114C	Aluminum w/ Double Pane	
114D	Aluminum w/ Double Pane	
101	Aluminum w/ Double Pane	
103	Aluminum w/ Double Pane	
122	Aluminum w/ Double Pane	
128	Aluminum w/ Double Pane	paint peeling
129	Aluminum w/ Double Pane	sealant peeling
131	Aluminum w/ Double Pane	
134	Aluminum w/ Double Pane	
134	Aluminum w/ Double Pane	
135	Aluminum w/ Double Pane	
133	Aluminum w/ Double Pane	
130	Aluminum w/ Double Pane	
127	Aluminum w/ Double Pane	
125	Aluminum w/ Double Pane	
121	Aluminum w/ Double Pane	
119	Aluminum w/ Double Pane	
106	Aluminum w/ Double Pane	
108	Aluminum w/ Double Pane
